## Report

Site Address: XXXXXXXX XXXXXXXX XXX XXX

08/07/26

### LEAK INVESTIGATION - ENTRANCE LOBBY CEILING

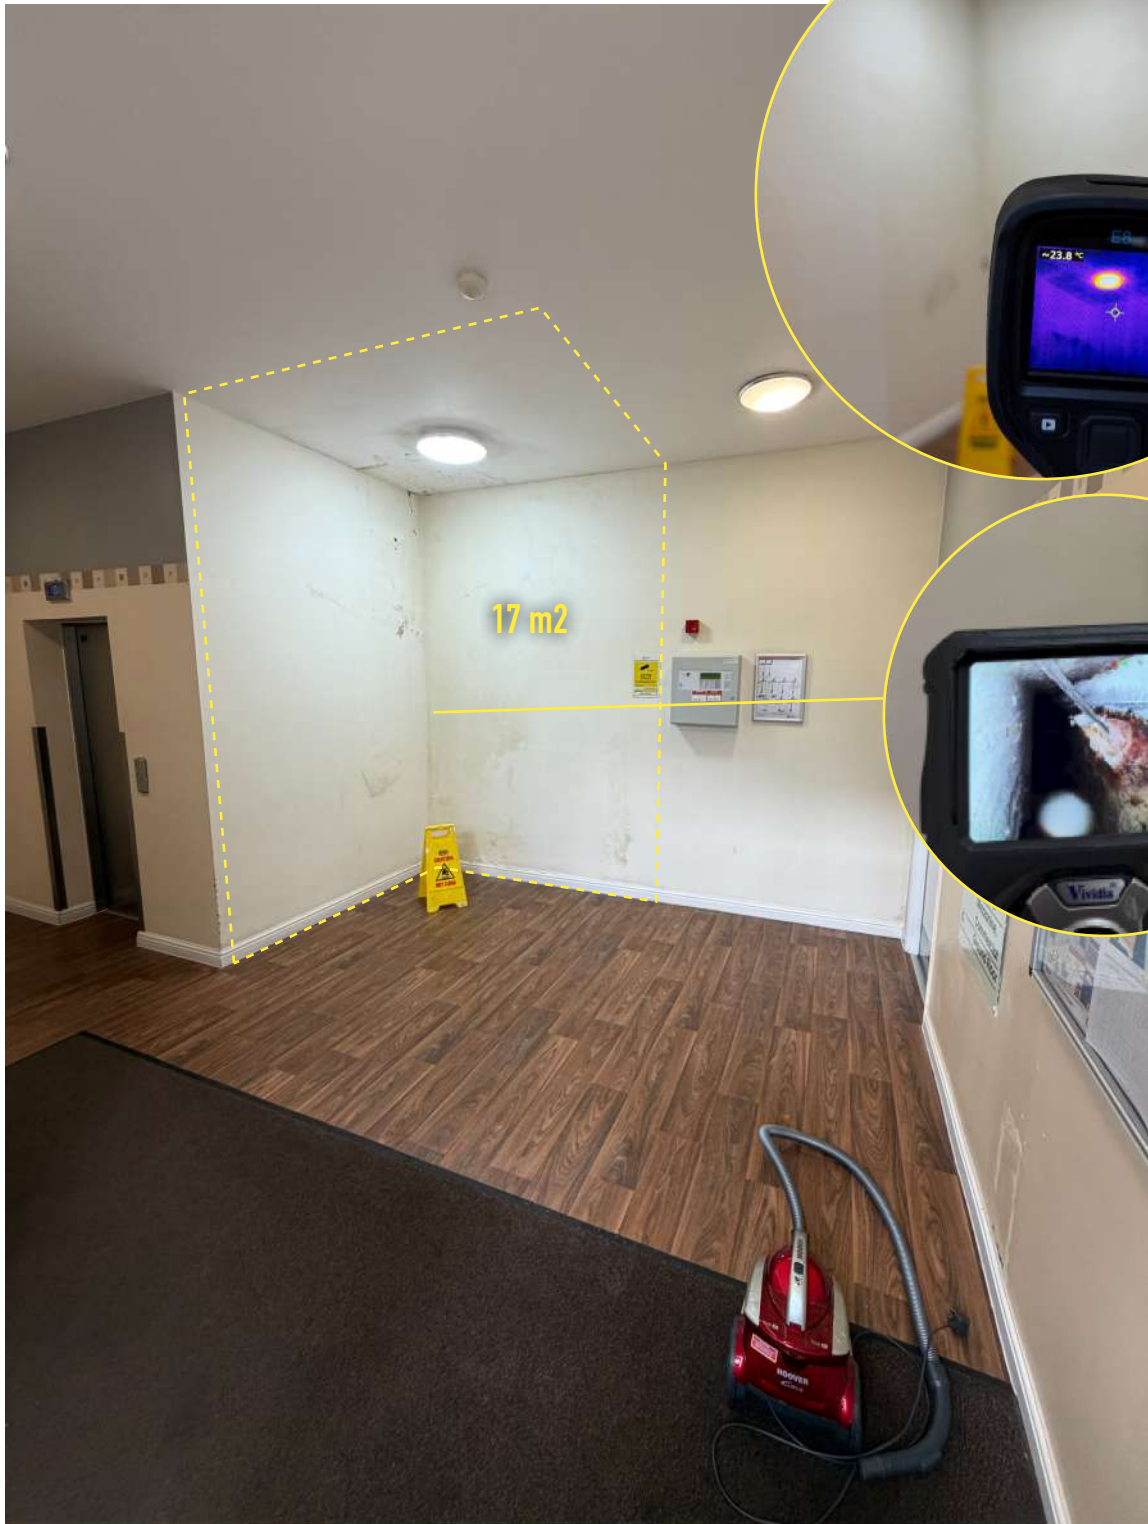
**ENTRANCE LOBBY:** The ceiling and walls show clear signs of water damage. Moisture testing confirmed that the affected areas are saturated, indicating ongoing water ingress rather than residual moisture from a historic leak. The lower image shows the rear face of the plasterboard with significant mould growth caused by prolonged moisture exposure. The plasterboard has been installed using the dot-and-dab method, resulting in isolated areas of higher moisture readings where the adhesive dabs are drawing moisture from the wall.

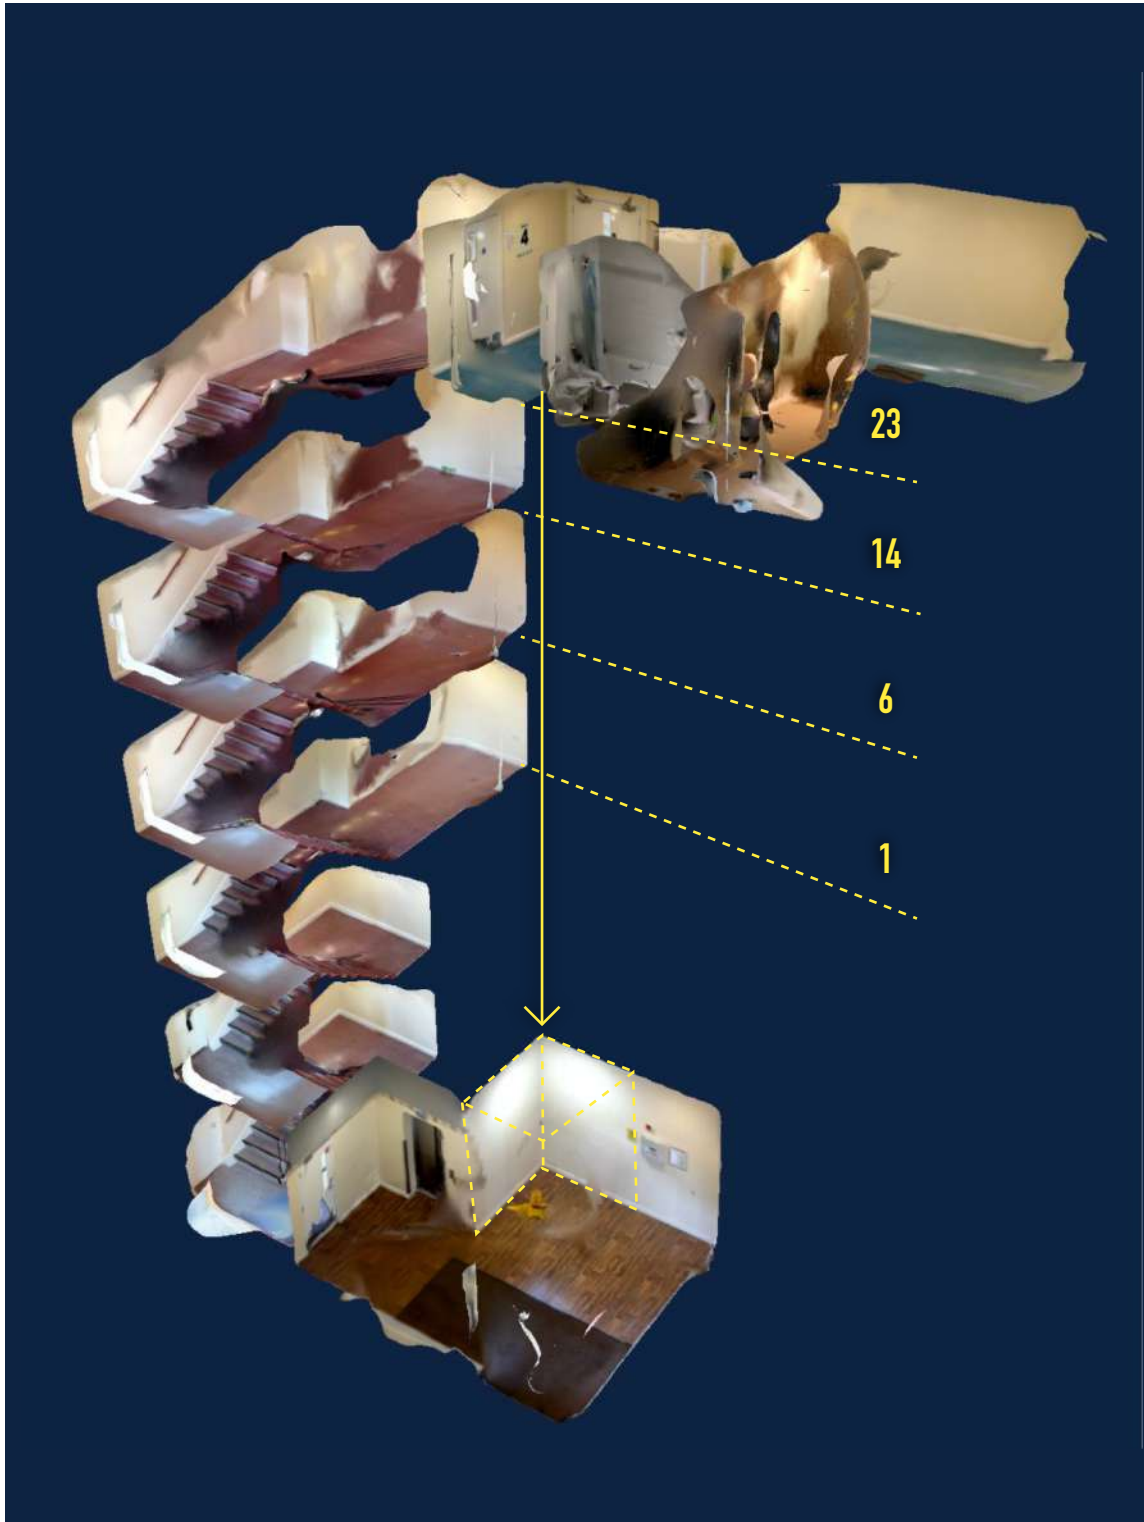
A 3D scan was used to identify the potential source of the leak. The scan revealed at least four bathrooms directly above the affected area. Access was only available to Flats 6 and 23 for inspection. During the inspections, it was noted that a soil stack pipe passes vertically through the bathroom of each flat and is positioned directly above the leak within the entrance lobby.

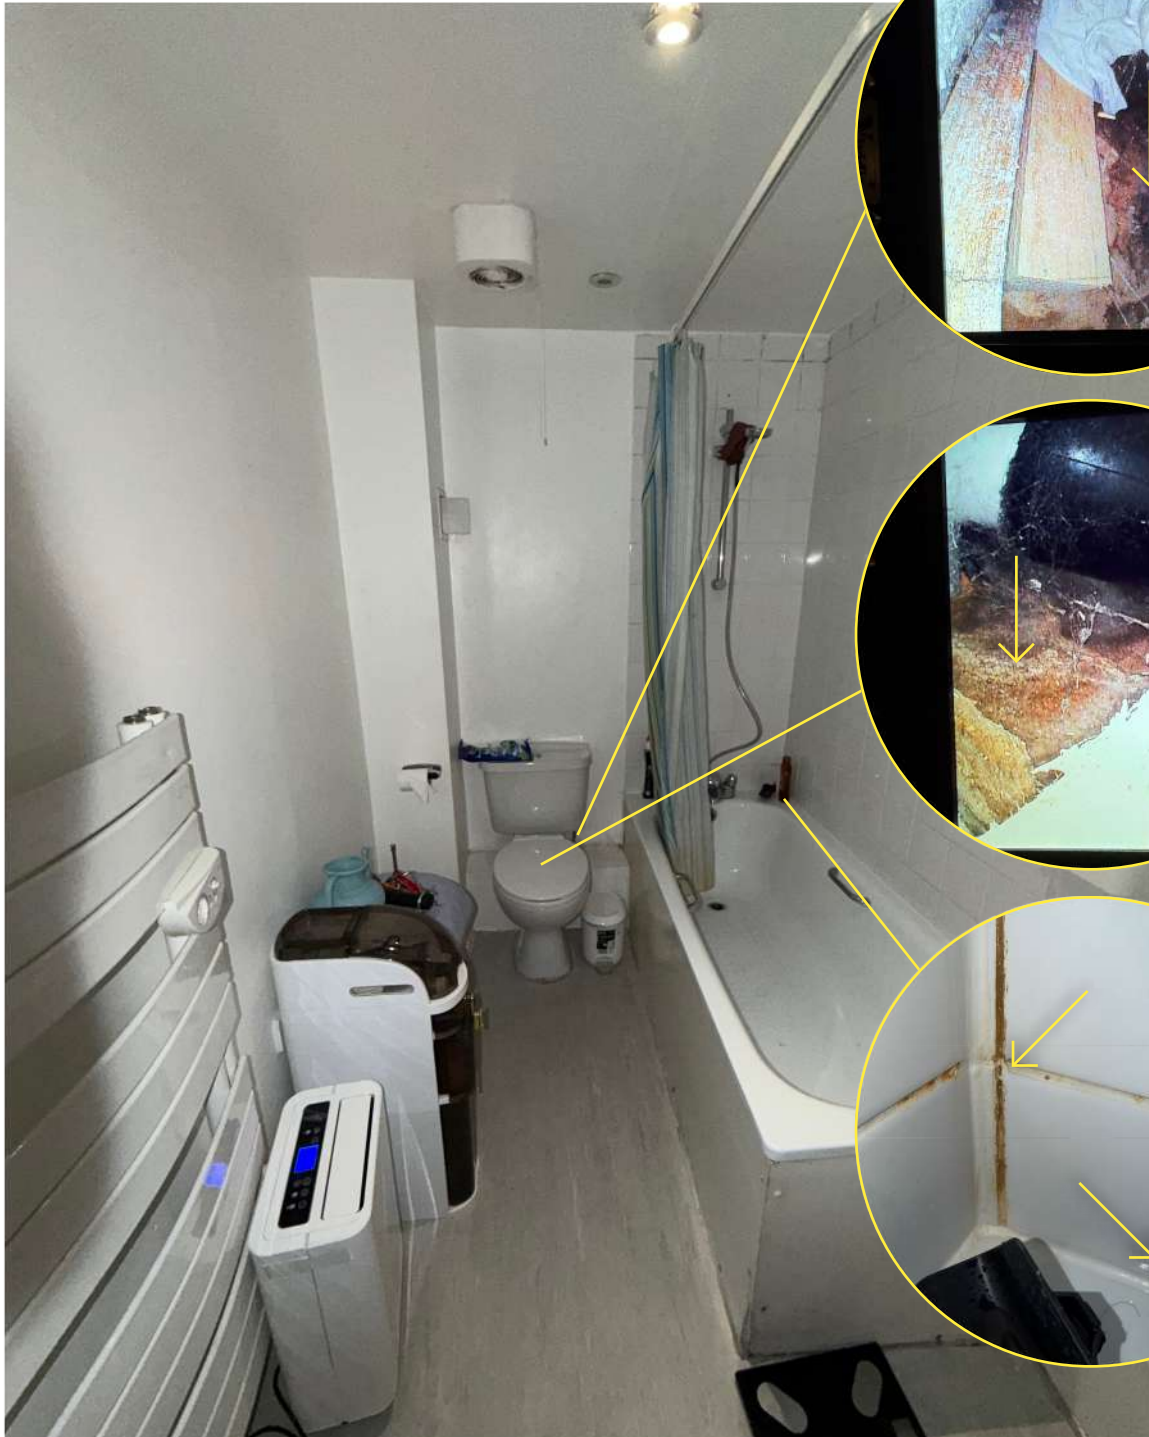
**FLAT 23:** The soil stack pipe was inspected first and found to be dry, with no obvious signs of leakage from above. The resident advised that she has young children and that water frequently overflows the bath during bath time. A Borescope camera was used to inspect the boxing behind the toilet. Moisture, water staining and fungal growth were observed within the void, confirming that water has been entering this area over a prolonged period. It is believed that repeated bath overflows have contributed significantly to the issue. In addition, minor leaks were identified from the toilet waste pipe and a nearby water supply pipe. Further inspection revealed that the corner of the bath panel was rotten, several joints around the bath were open, and the silicone sealant had been poorly applied. Cracked wall tiles and deteriorated grout joints were also present, providing multiple pathways for water to escape. These defects are collectively contributing to the water ingress. It is highly likely that water is entering the structural slab through the service opening formed around the soil stack pipe and then travelling down the same route as the pipe

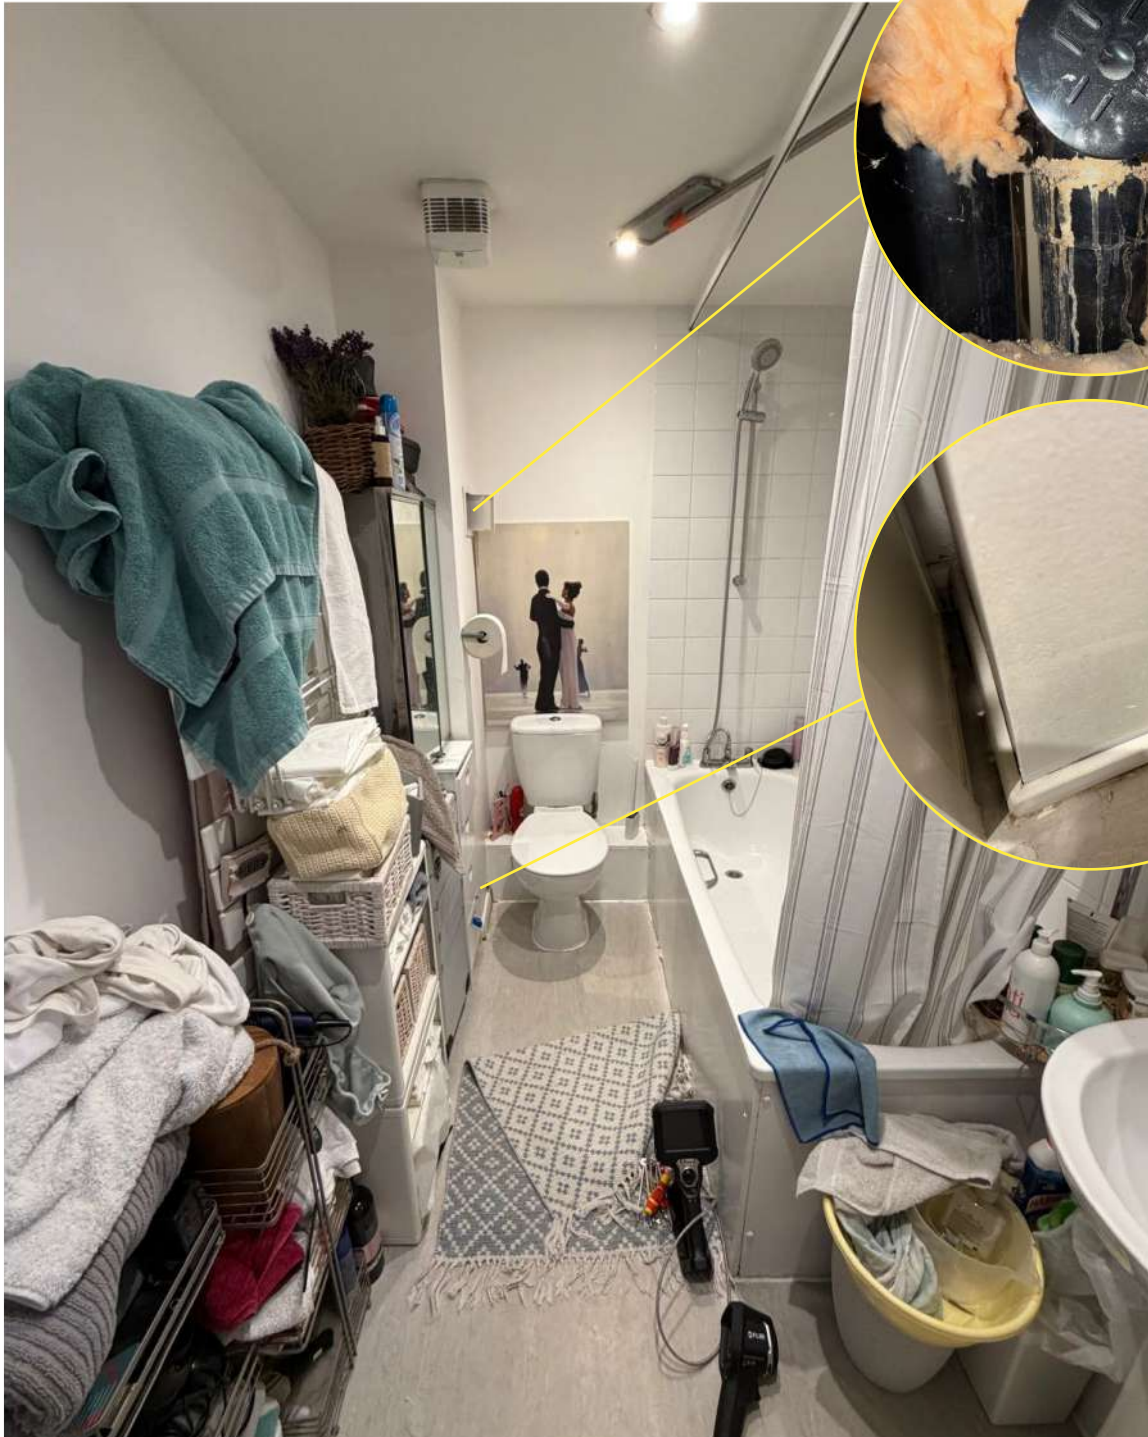
**FLAT 6:** The soil stack pipe was inspected and found to be dry at the time of our investigation. However, there was clear evidence of historic leakage, with limescale deposits and water run marks visible on the pipework. The resident advised that water had previously flowed from the underside of the boxing-in enclosing the stack pipe, indicating water ingress from one of the flats above. Although this had not occurred for several weeks, the surrounding water staining confirms a prolonged leak. The resident also advised that the bath mixer tap had recently been replaced due to a leak. As access was only gained to Flats 6 and 23, we recommend inspections of Flats 1 and 14, as defects within these properties could also be contributing to the leak affecting the entrance lobby below.
